Manhole Inspection Summary

Manhole # S29YY_028MH

Insp Date: **5/23/07 9:42 AM**

Location Address: **3351 HARDING PL**

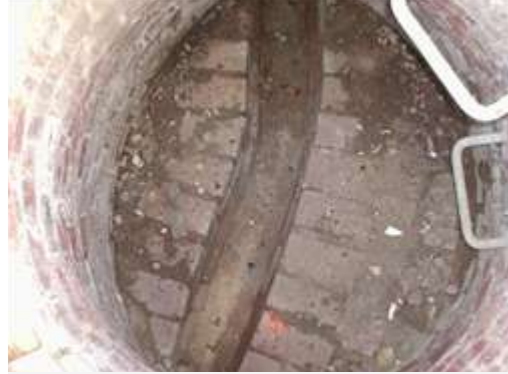
Top View

Bench debris.

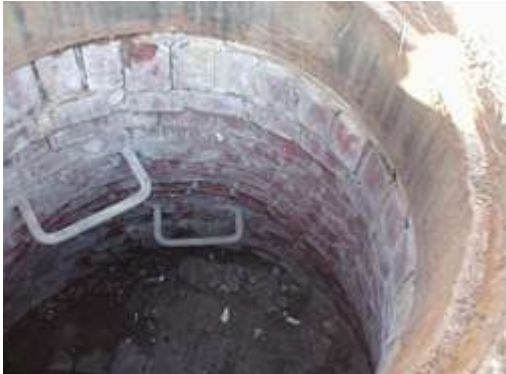
Defect

Frame leaks. Adjustment deterioration and infiltration. Corbel and Barrel infiltration - other side.

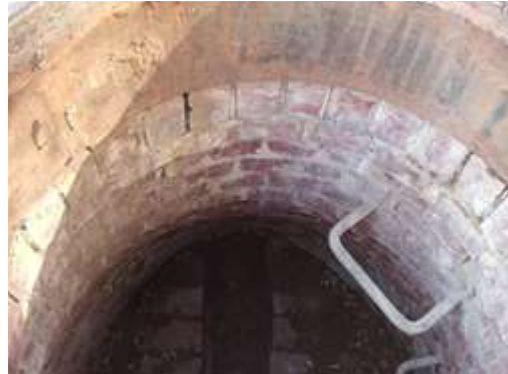
Defect

Frame leaks. Adjustment deterioration and infiltration. Corbel and Barrel infiltration.

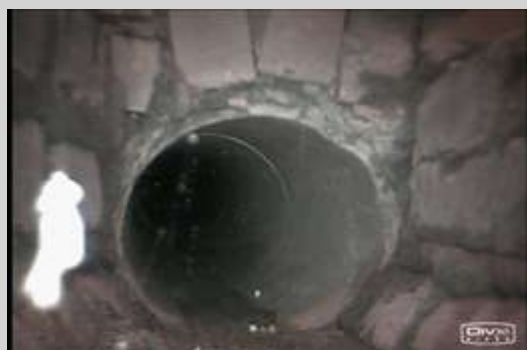
Pipe Out @ 12 O'Clock

Channel deterioration.

Infiltration: **Evidence** Pipe Seal Cond: **Cracked**

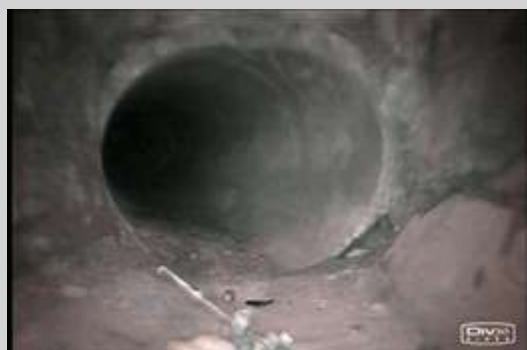
Pipe In @ 7 O'Clock

Deposits: ☐ None ☒ **Mud** ☐ Sludge ☒ **Debris** ☐ Grease

Silt Depth: **0.5** (in.) Deposits Extent: **Light**

Infiltration: **Evidence** Pipe Seal Cond: **Unknown**
